**ADDENDUM TO
ARCH CANYON CONDITION ASSESSMENT
AND MANAGEMENT RECOMMENDATIONS
Report for the
Southern Utah Wilderness Association**

This is an addendum to the August, 2006, report entitled “ARCH CANYON CONDITION ASSESSMENT AND MANAGEMENT RECOMMENDATIONS” prepared by ECOS Consulting for the Southern Utah Wilderness Association.

DAMAGE ASSESSMENT OF OCTOBER FLOODS

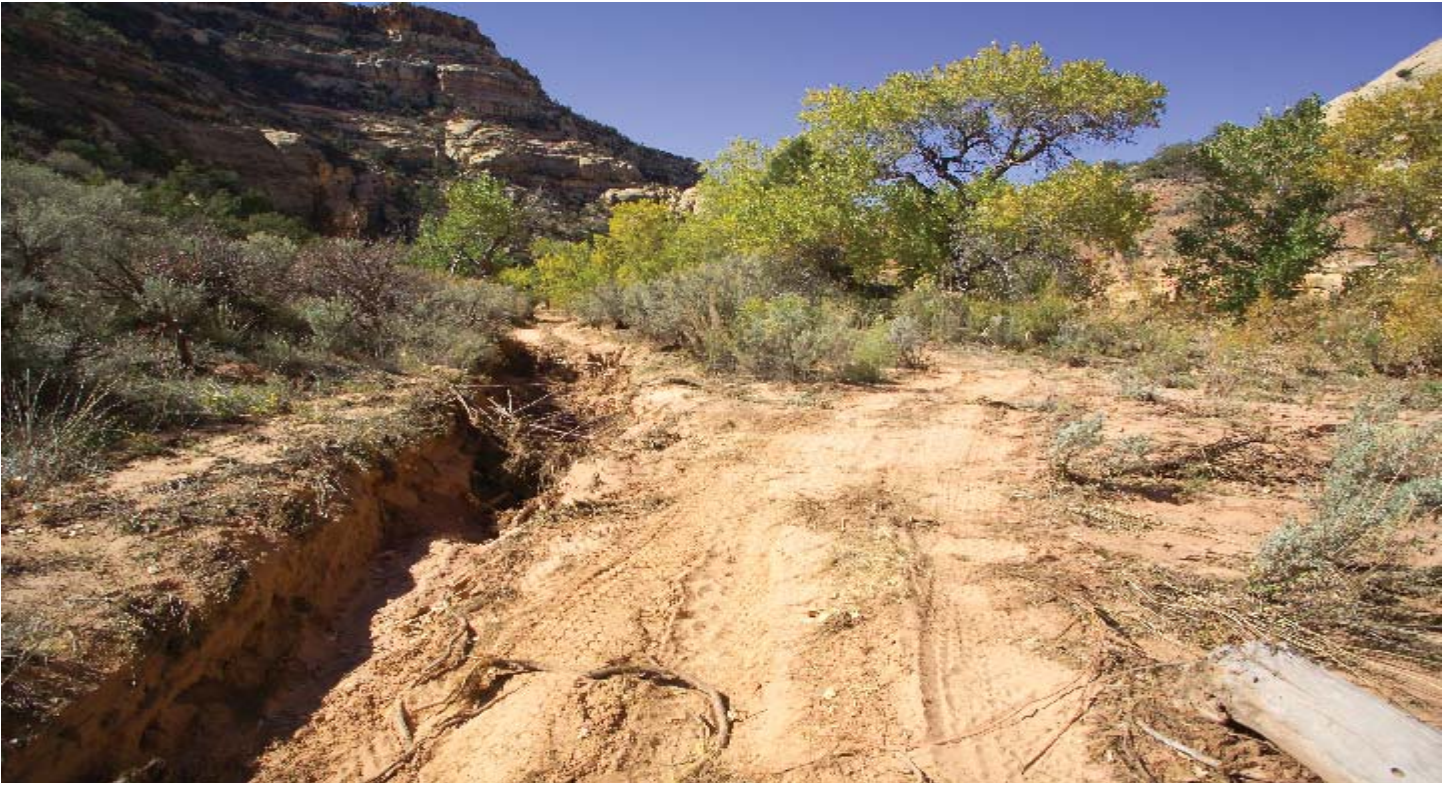
Figure 21. Photo taken in October, 2006. This is flood damage caused by water flowing down the 4-wheel drive route. The route has recently been diverted around the gully. Arch Canyon, San Juan County, Utah.

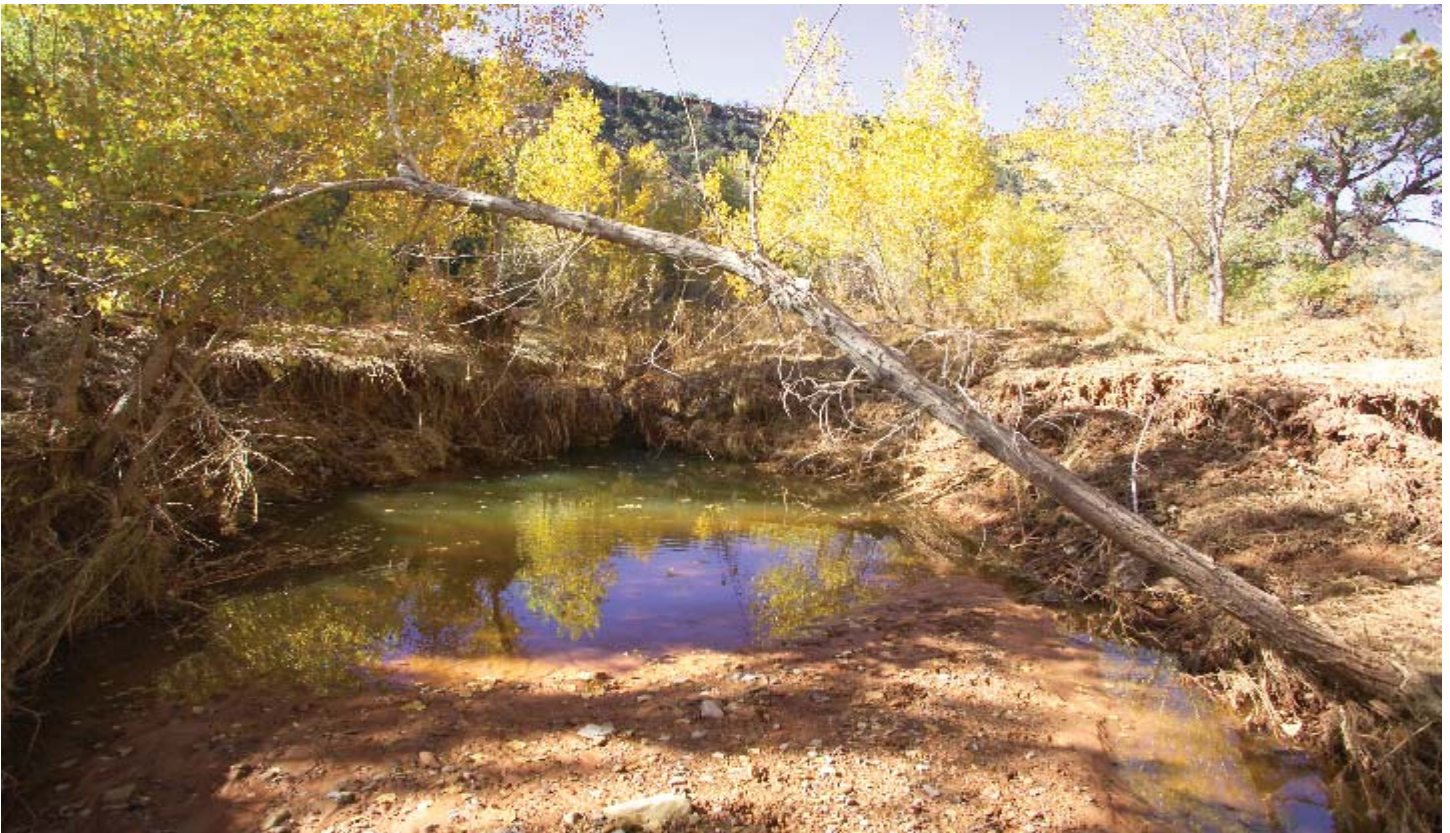
Figure 22. Additional flood damage from the tremendous energy of the flow that was augmented by the 4-wheel drive route over which much of the water flowed. Arch Canyon, San Juan County, Utah.

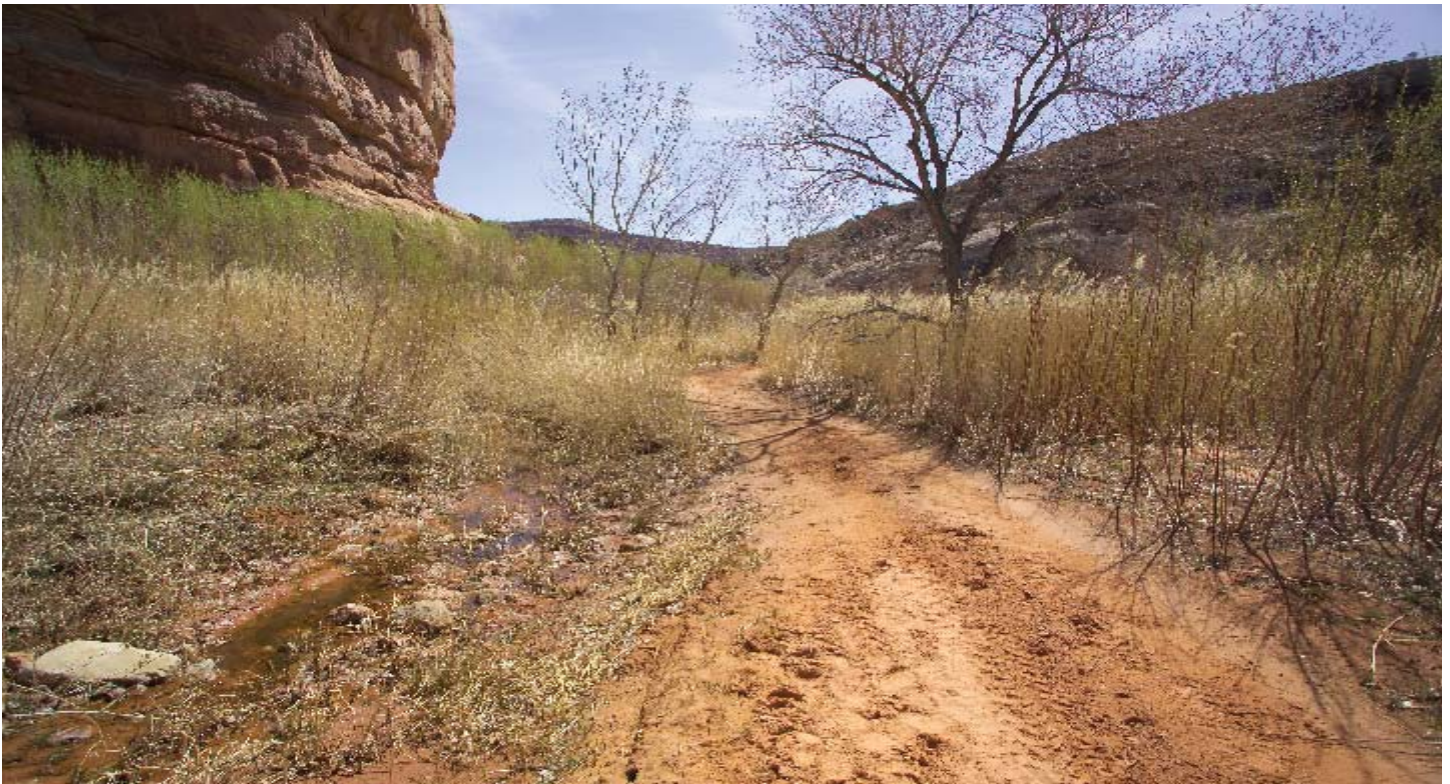
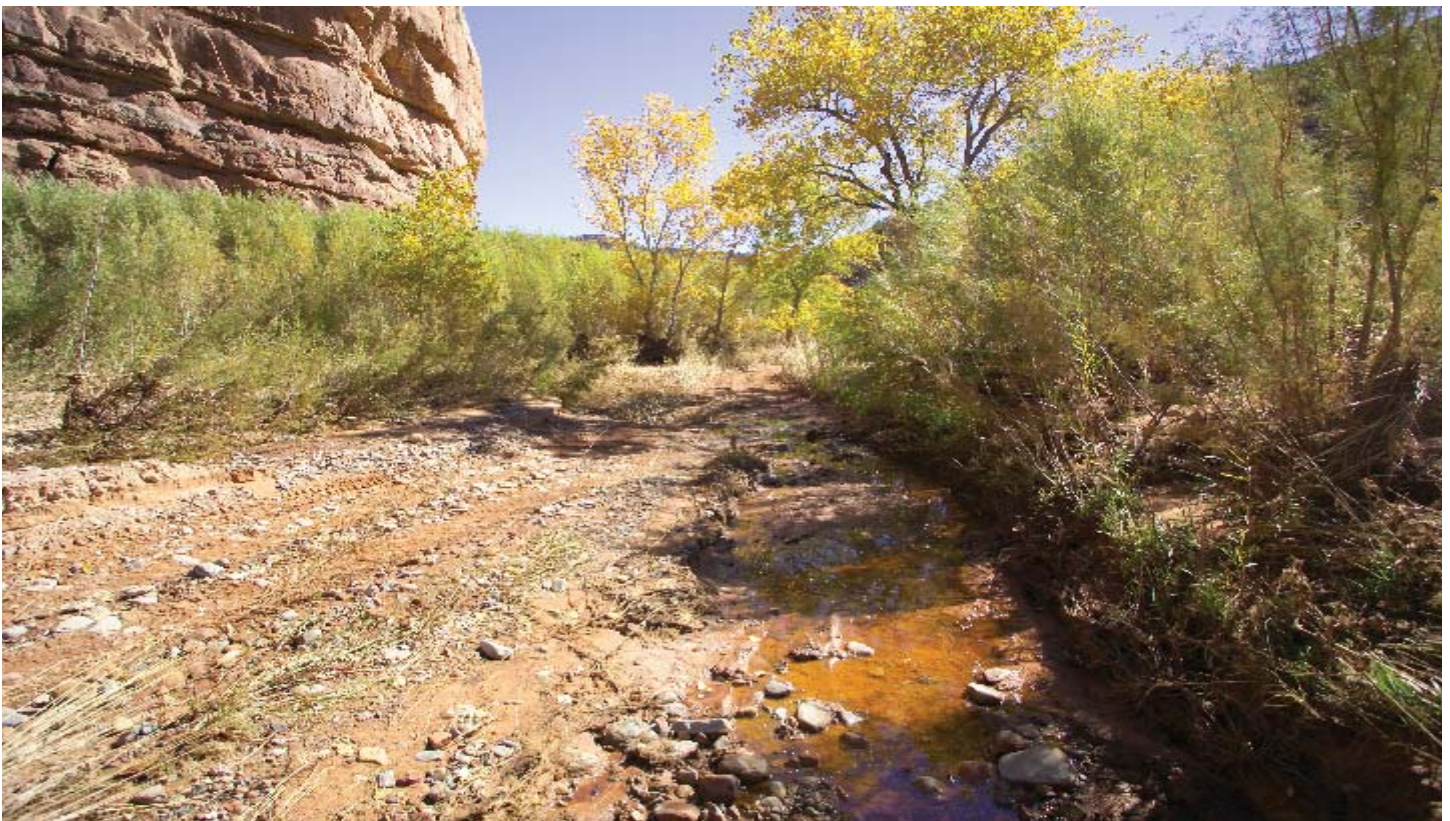
Figure 3a. Photo taken in April, 2006. This is a proper functioning section of the streambed. Note the thick riparian vegetation on both sides of the 4-wheel drive route. Arch Canyon, San Juan County, Utah.

Figure 3b. Repeat photo of Figure 3a, taken in October, 2006. The 4-wheel drive route funneled water through and caused extensive damage through widening and deepening around the route. Other areas with thick vegetation stayed intact. Arch Canyon, San Juan County, Utah.

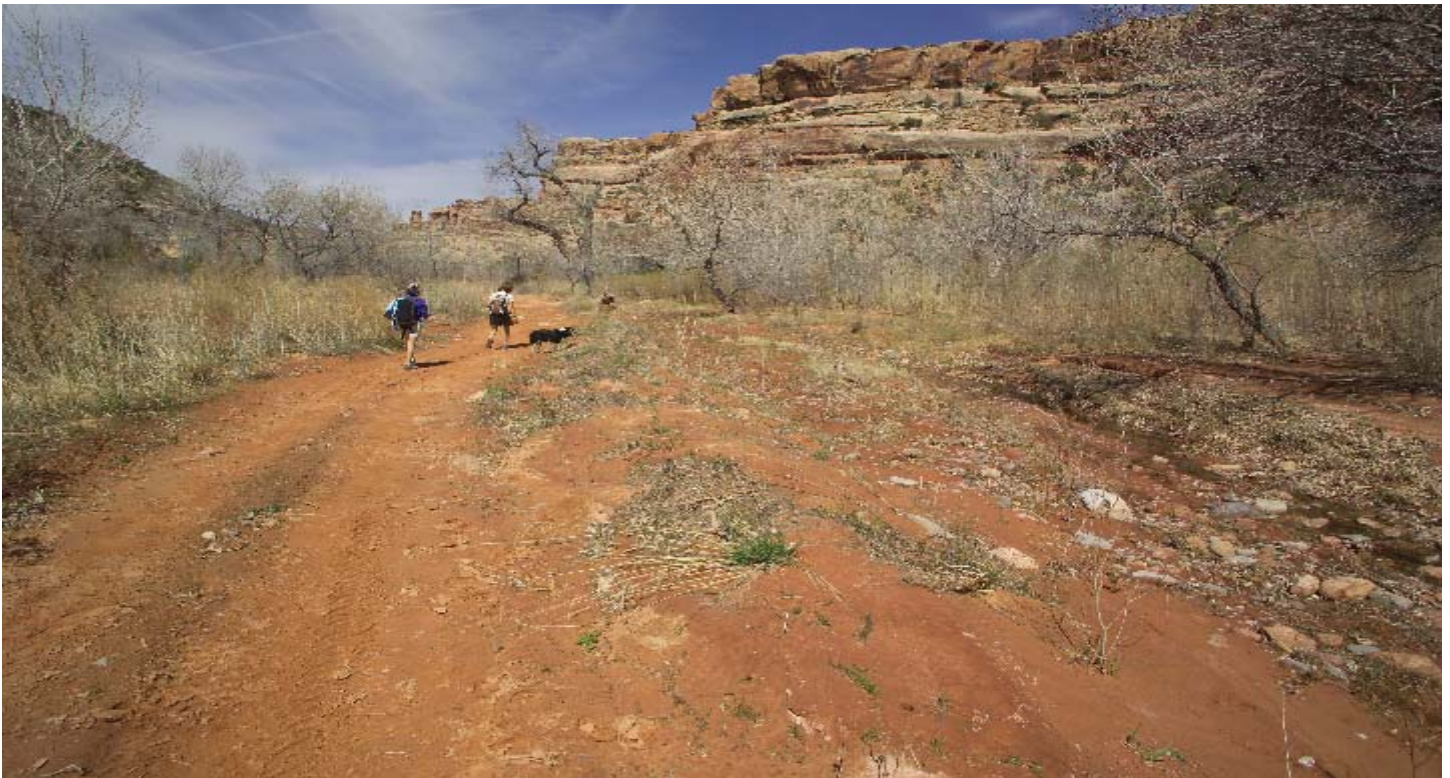
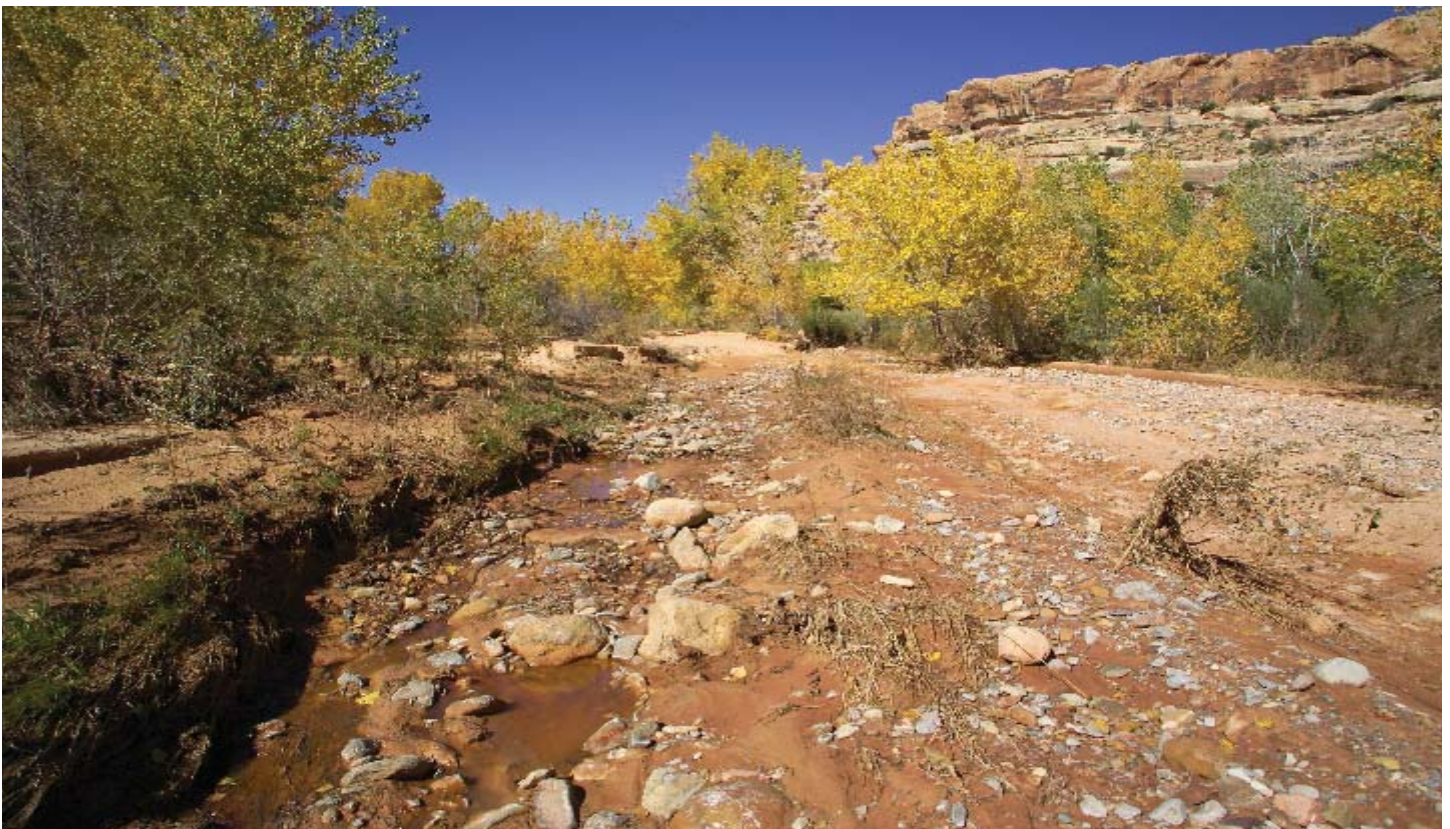
Figure 4a. Photo taken in April, 2006. Note the thick riparian vegetation on both sides of the 4-wheel drive route. Arch Canyon, San Juan County, Utah.

Figure 4b. Repeat photo of Figure 4a, taken in October, 2006. The 4-wheel drive route carried a large portion of the flood load and scoured out the route into a new channel. The thick vegetation on the sides protected those areas and tended to shunt the flood waters into the 4-wheel drive route. Arch Canyon, San Juan County, Utah.

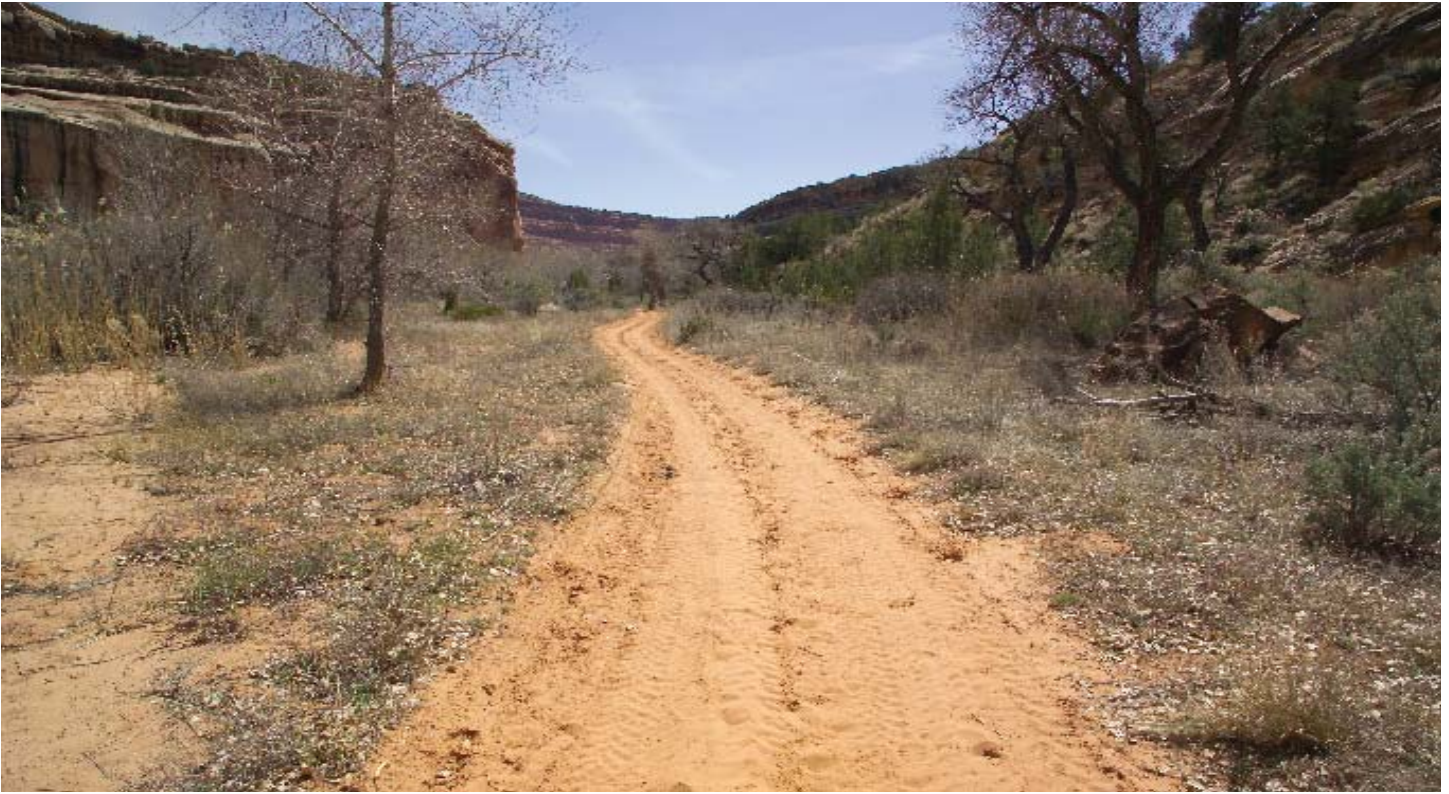
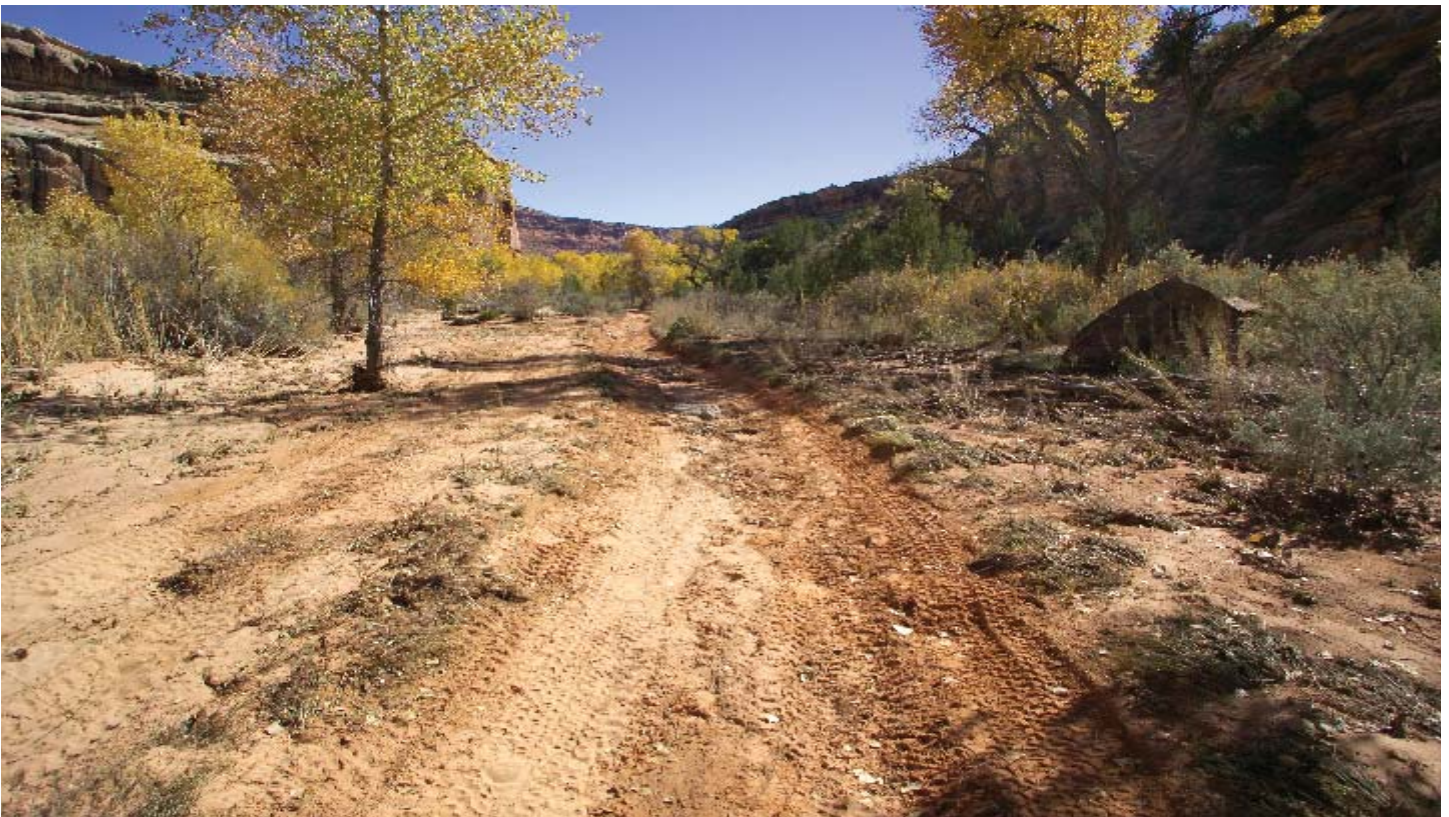
Figure 5a. Photo taken in April, 2006. 4-wheel drive route facing upstream; stream channel is out of sight on left. Arch Canyon, San Juan County, Utah.

Figure 5b. Repeat photo of Figure 5a, taken in October, 2006. Flood waters jumped onto the 4-wheel drive route and caused much soil and bank erosion, and elimination of vegetation. Arch Canyon, San Juan County, Utah.

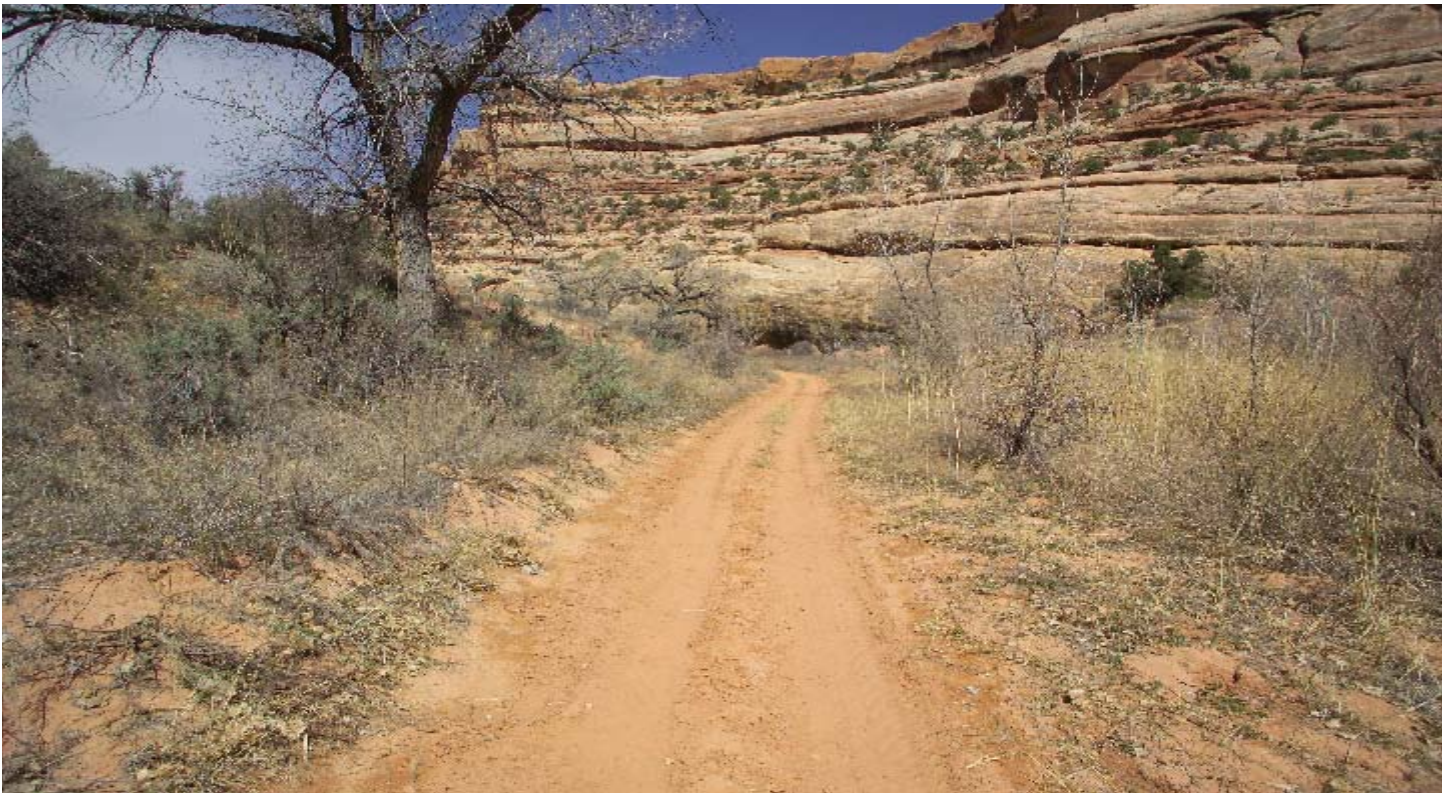
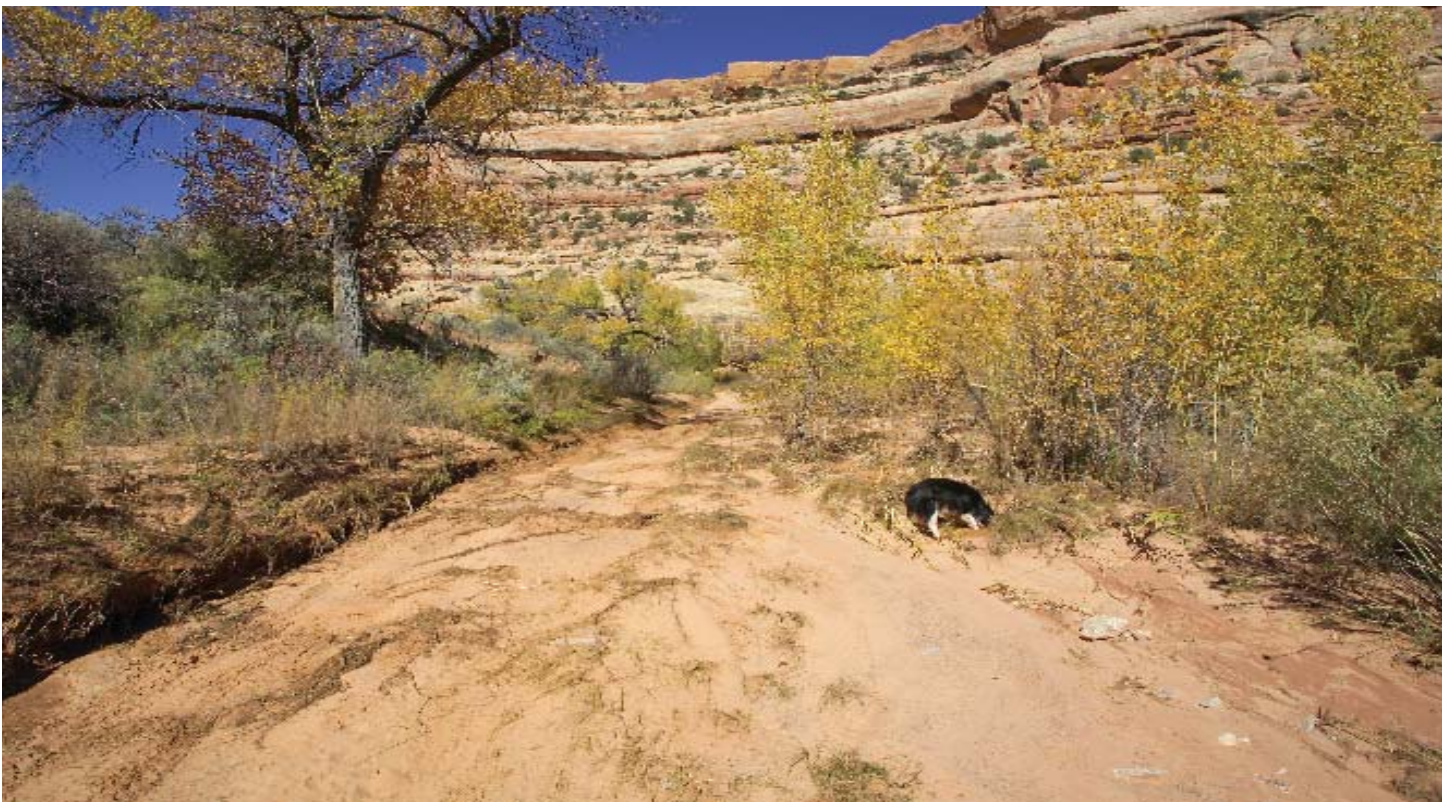
Figure 6a. Photo taken in April, 2006. 4-wheel drive route facing upstream; stream channel is on right. Arch Canyon, San Juan County, Utah.

Figure 6b. Repeat photo of Figure 6a, taken in October, 2006. The 4-wheel drive route experienced heavy flow and caused much soil and bank erosion. The route is now becoming part of the stream channel, especially when there is a flood. Arch Canyon, San Juan County, Utah.

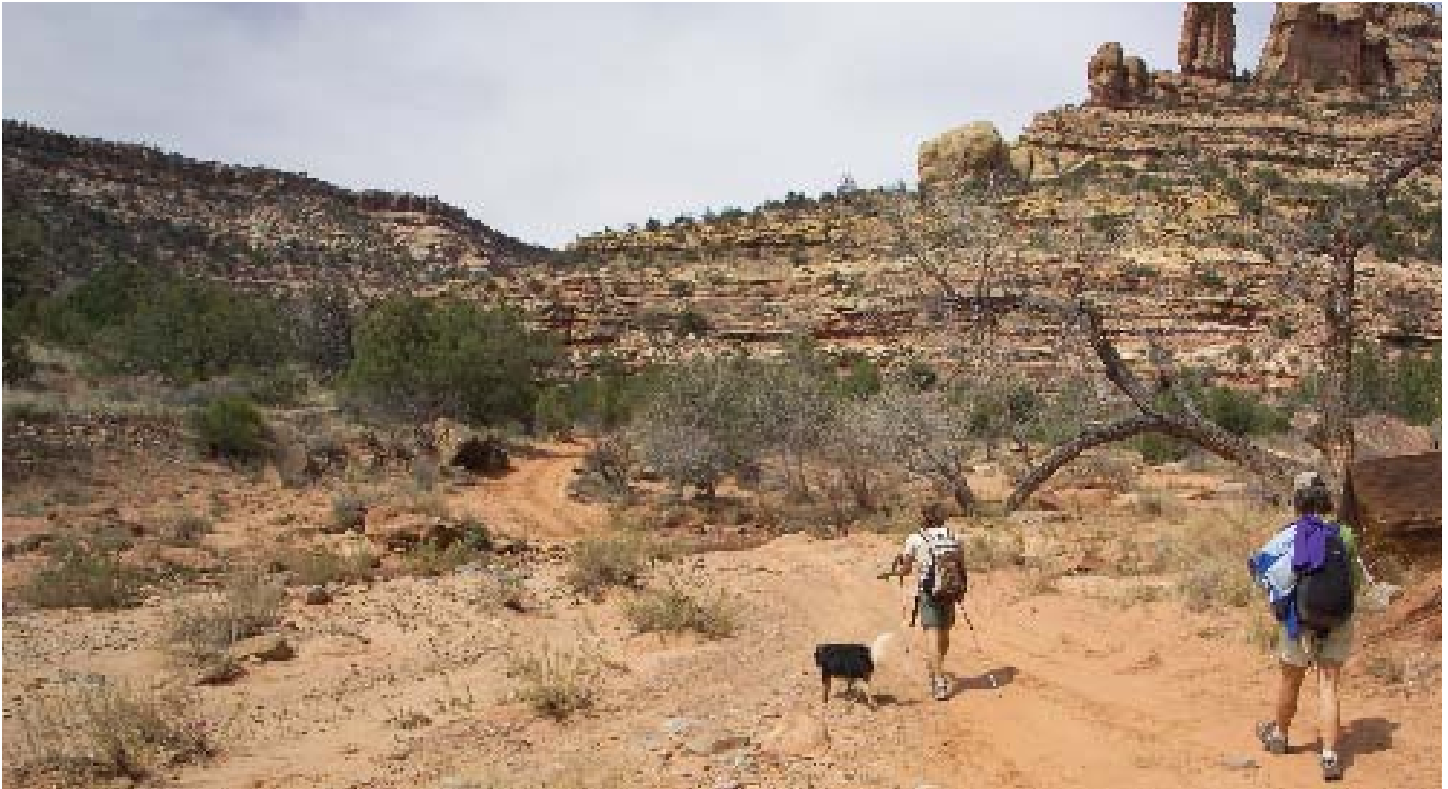
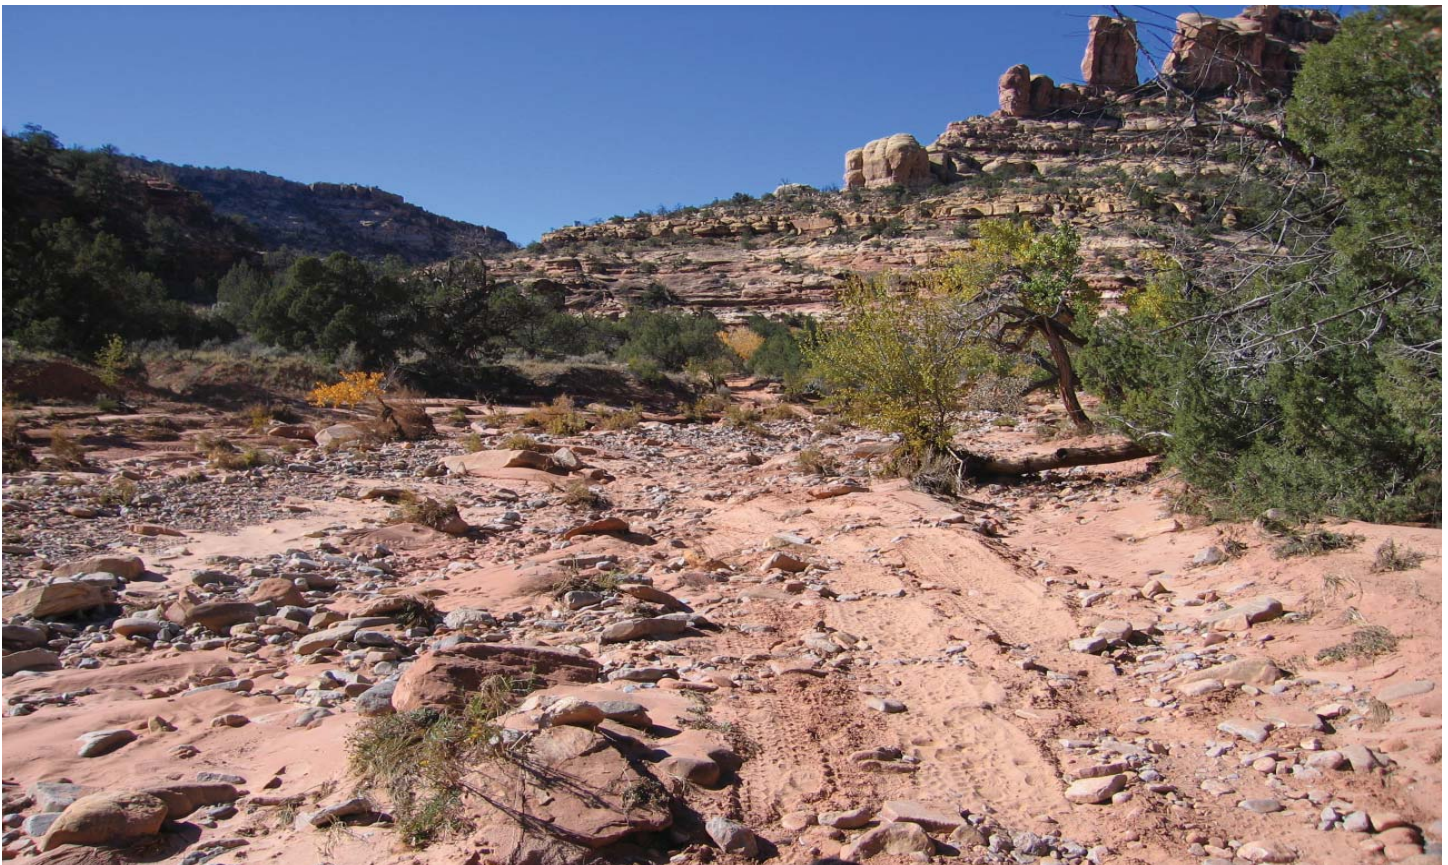
Figure 7a. Photo taken in April, 2006. Upstream view from where 4-wheel drive route exits the stream channel. Arch Canyon, San Juan County, Utah.

Figure 7b. Repeat photo of Figure 7a, taken in October, 2006. Many plants have been eliminated between the 4-wheel drive route and the channel as flow was diverted onto the route during flooding. Arch Canyon, San Juan County, Utah.

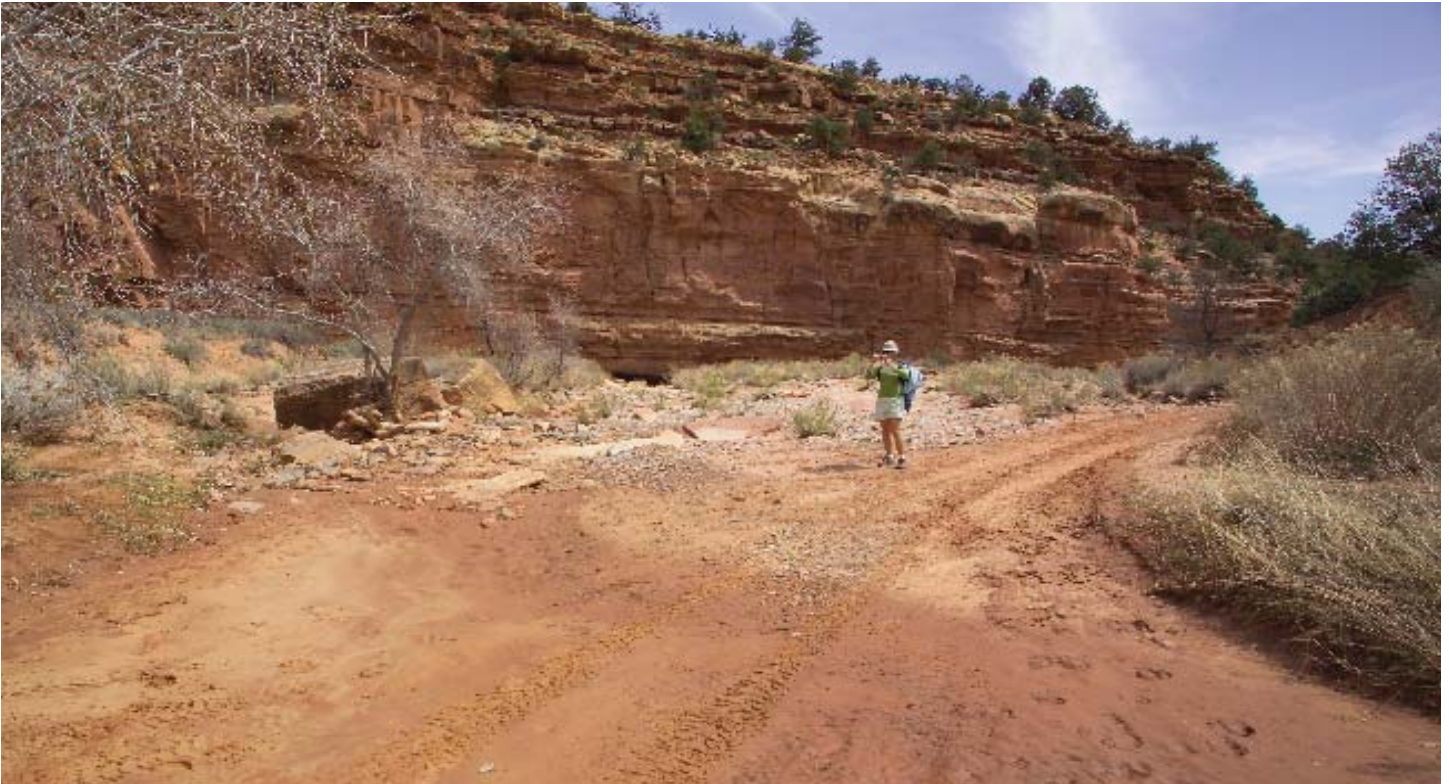
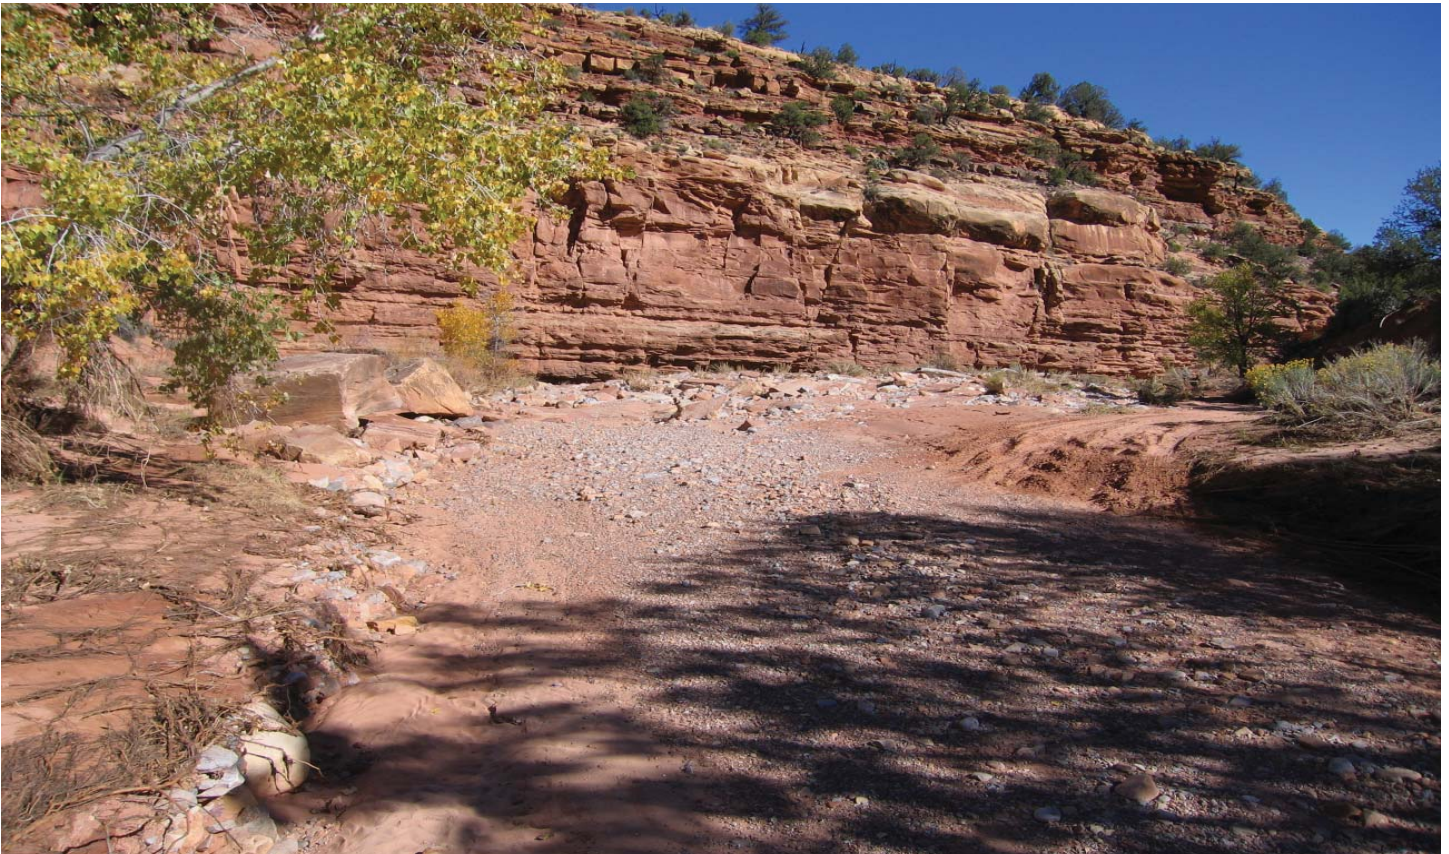
Figure 8a. Photo taken in April, 2006. Downstream view where 4-wheel drive route crosses the stream channel. Arch Canyon, San Juan County, Utah.

Figure 8b. Repeat photo of Figure 8a, taken in October, 2006. Note the erosion and loss of vegetation along the bank on the left side and the exposure of tree roots. Arch Canyon, San Juan County, Utah.

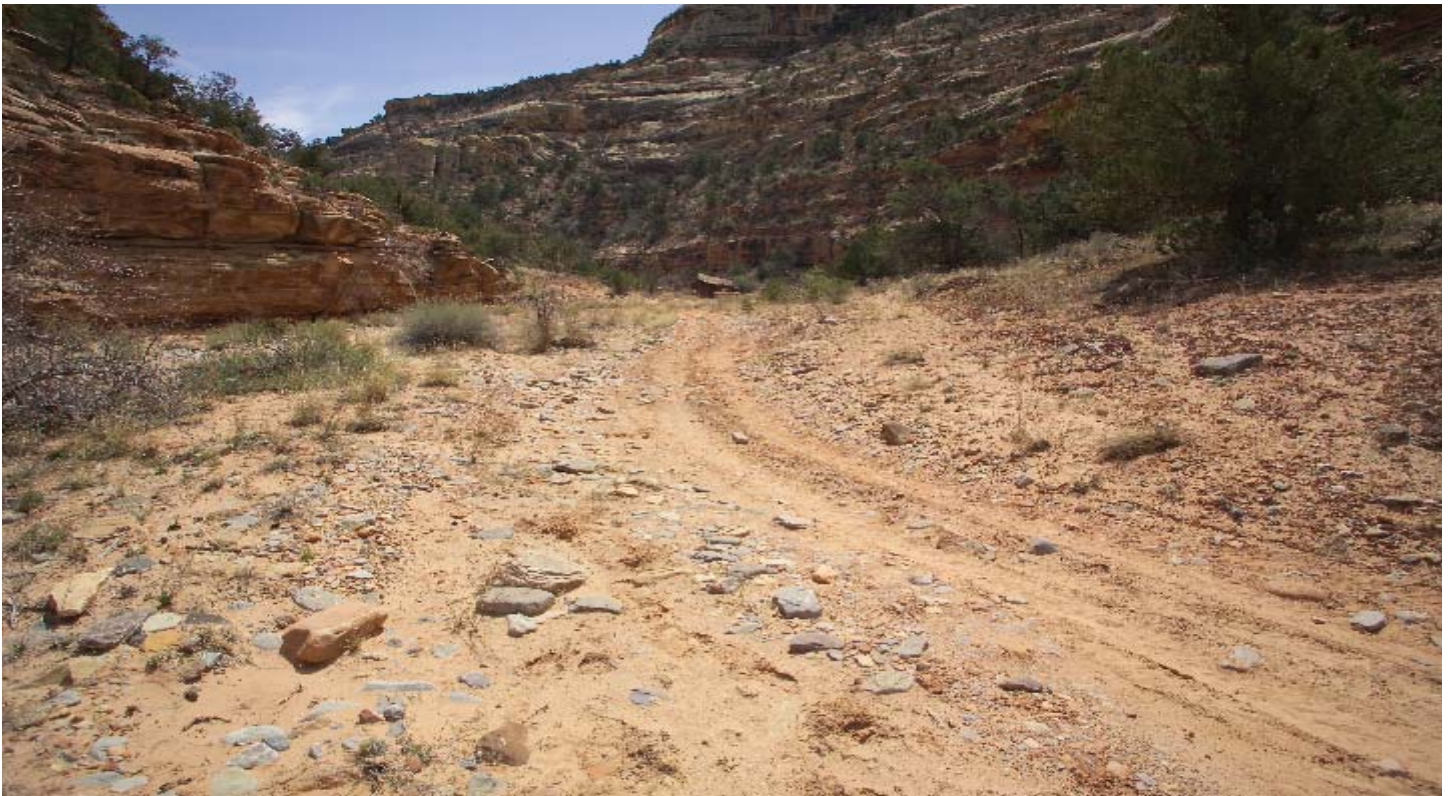
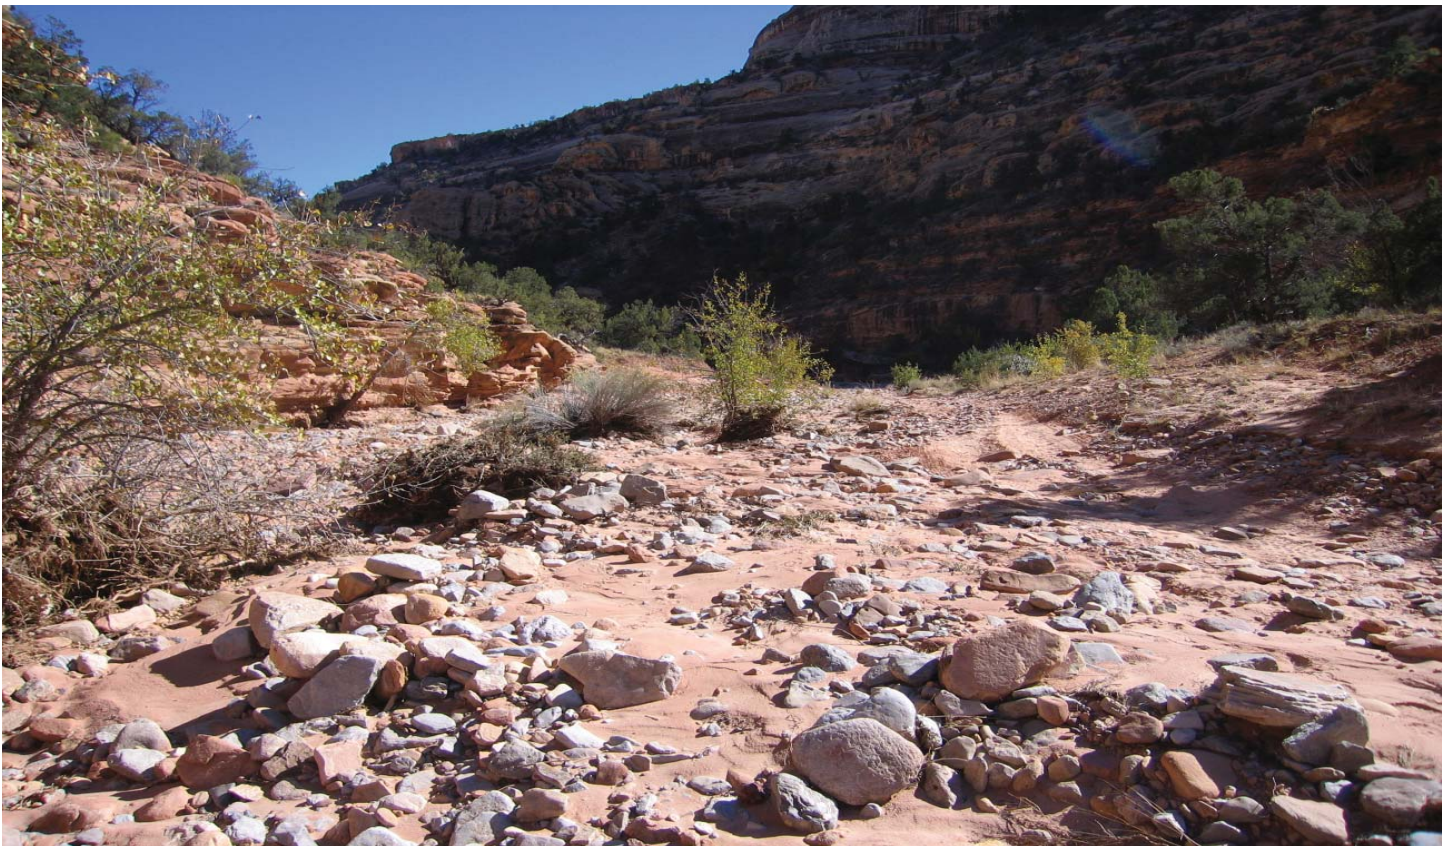
Figure 9a. Photo taken in April, 2006. Downstream view where 4-wheel drive route crosses the stream channel. Arch Canyon, San Juan County, Utah.

Figure 9b. Repeat photo of Figure 9a, taken in October, 2006. Flood waters followed the 4-wheel drive route and eroded away the streambank and vegetation between the road and the channel. Also note the erosion of soil and exposure of large rocks from the tremendous energy of the early October floods. Arch Canyon, San Juan County, Utah.

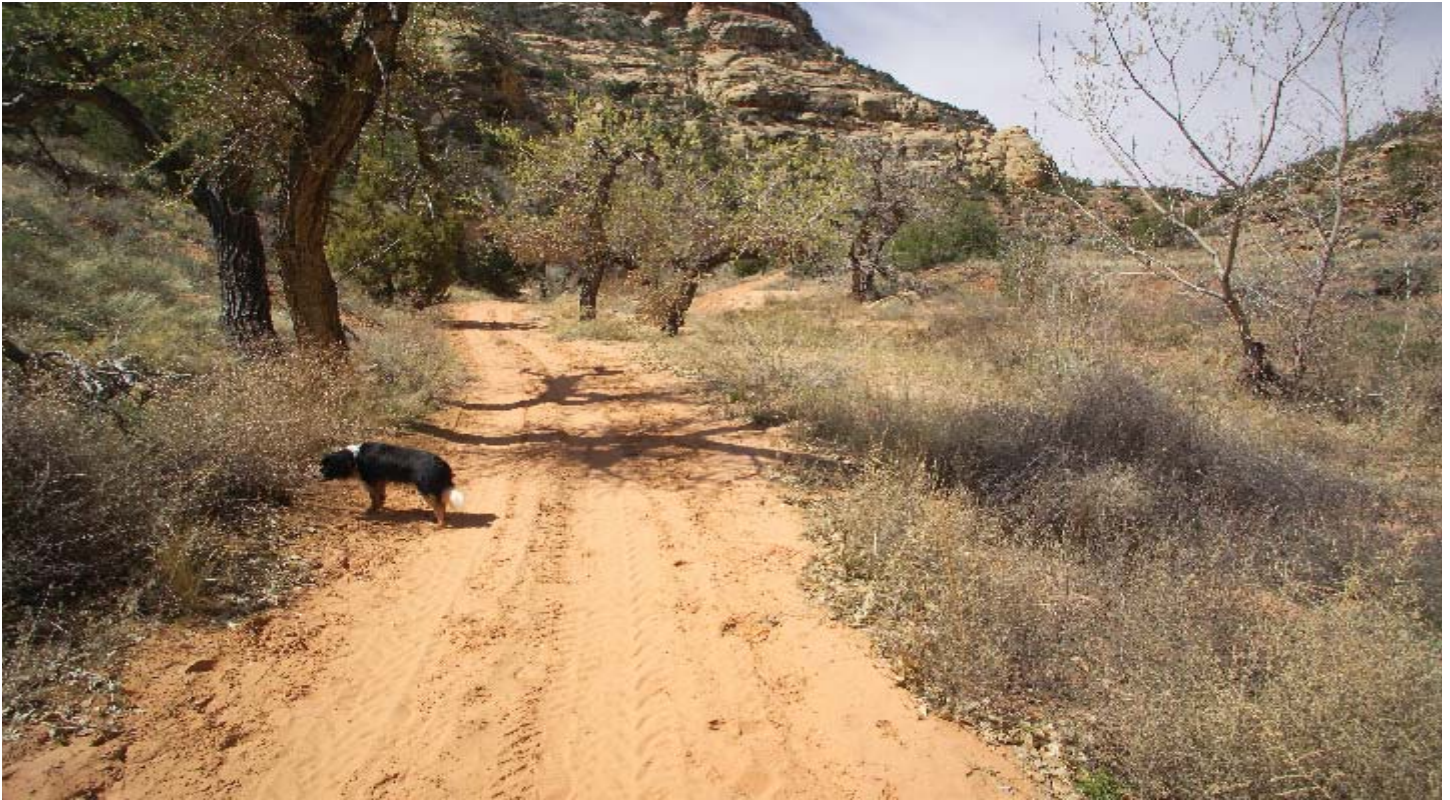
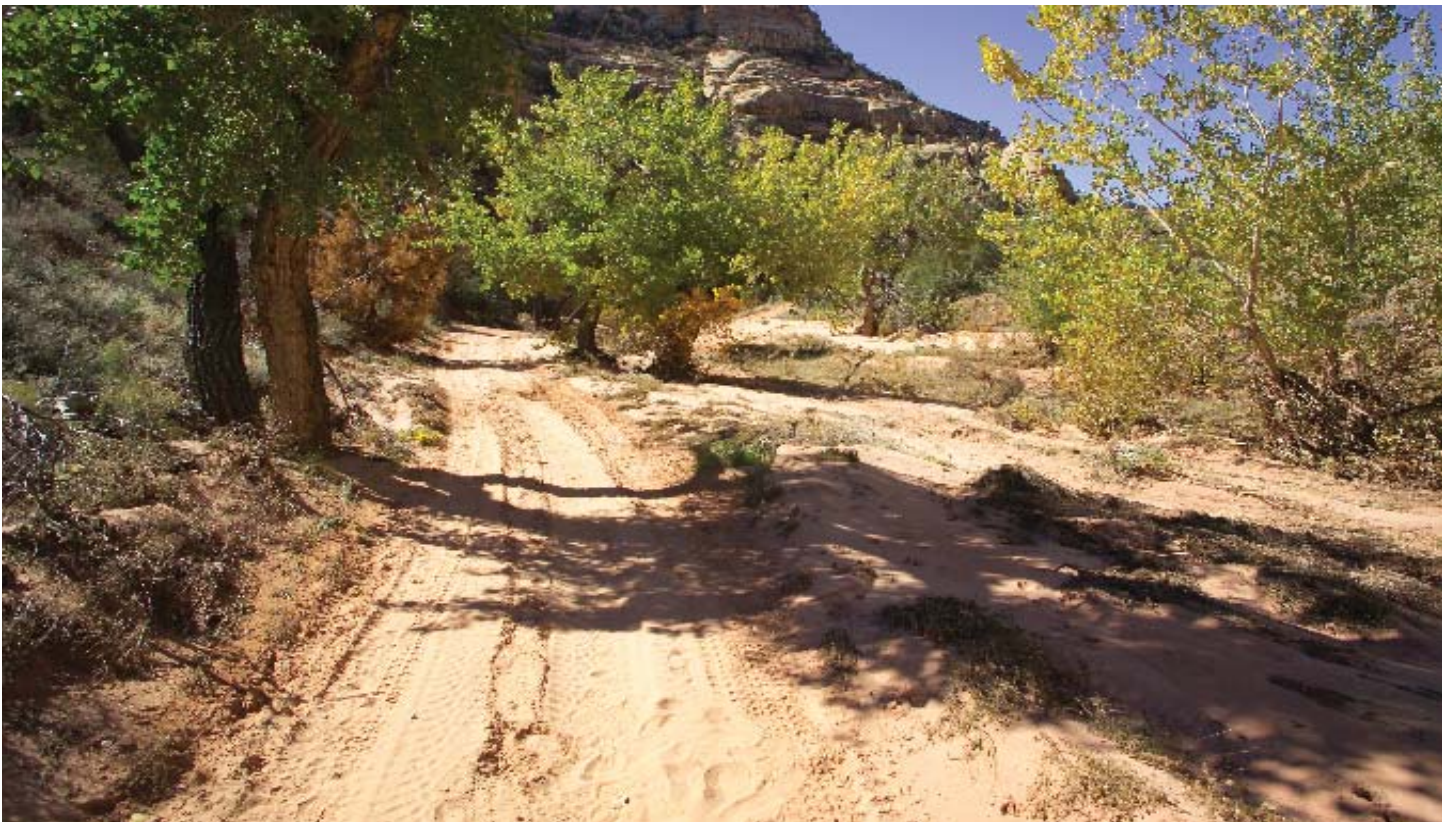
Figure 10a. Photo taken in April, 2006. 4-wheel drive route facing upstream; stream channel is on right. Arch Canyon, San Juan County, Utah.

Figure 10b. Repeat photo of Figure 10a, taken in October, 2006. Flood waters flowed down the 4-wheel drive route and swept away the soil and vegetation between the route and the stream channel. Arch Canyon, San Juan County, Utah.
