**ADDENDUM TO
ARCH CANYON CONDITION ASSESSMENT
AND MANAGEMENT RECOMMENDATIONS
Report for the
Southern Utah Wilderness Association**

This is an addendum to the August, 2006, report entitled “ARCH CANYON CONDITION ASSESSMENT AND MANAGEMENT RECOMMENDATIONS” prepared by ECOS Consulting for the Southern Utah Wilderness Association.

DAMAGE ASSESSMENT OF OCTOBER FLOODS

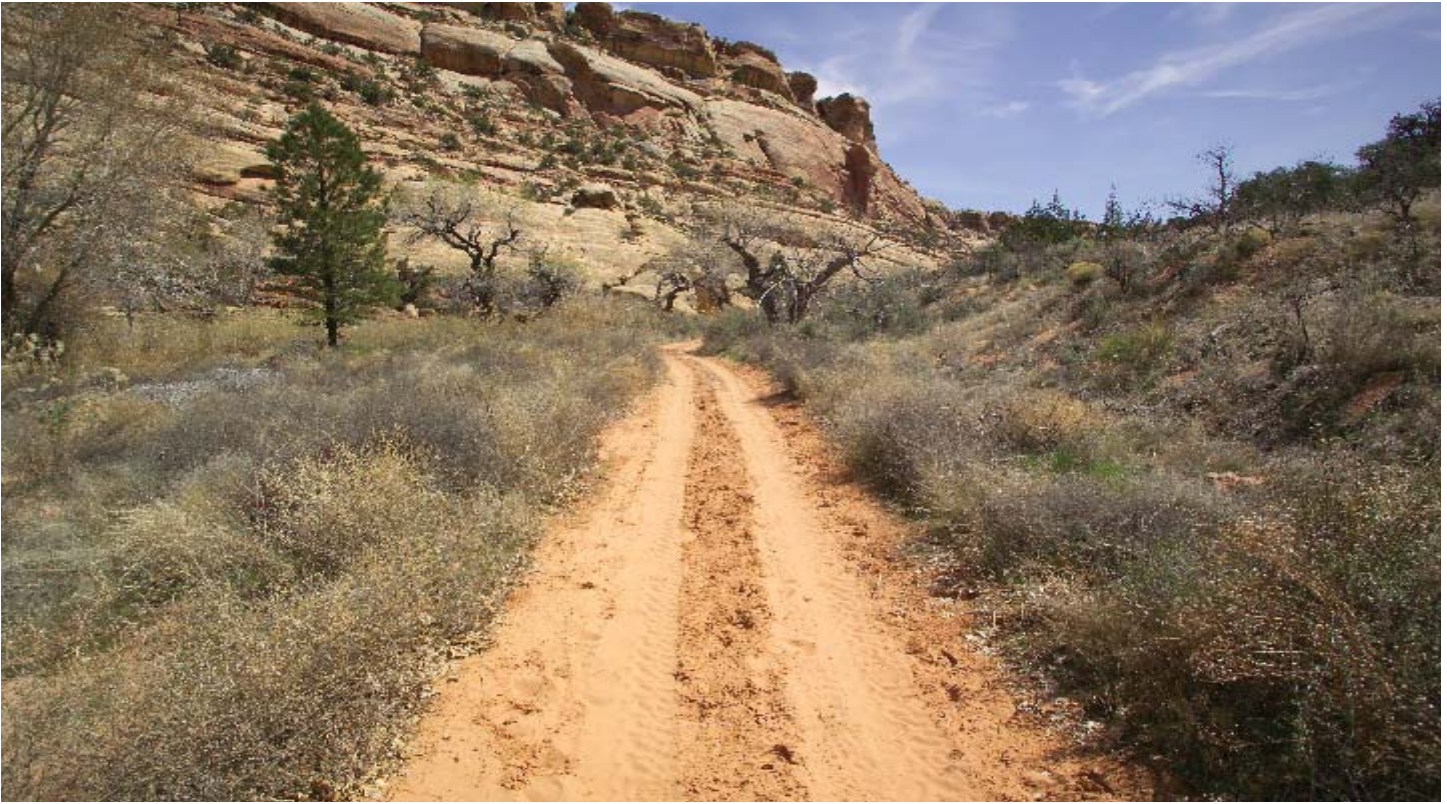
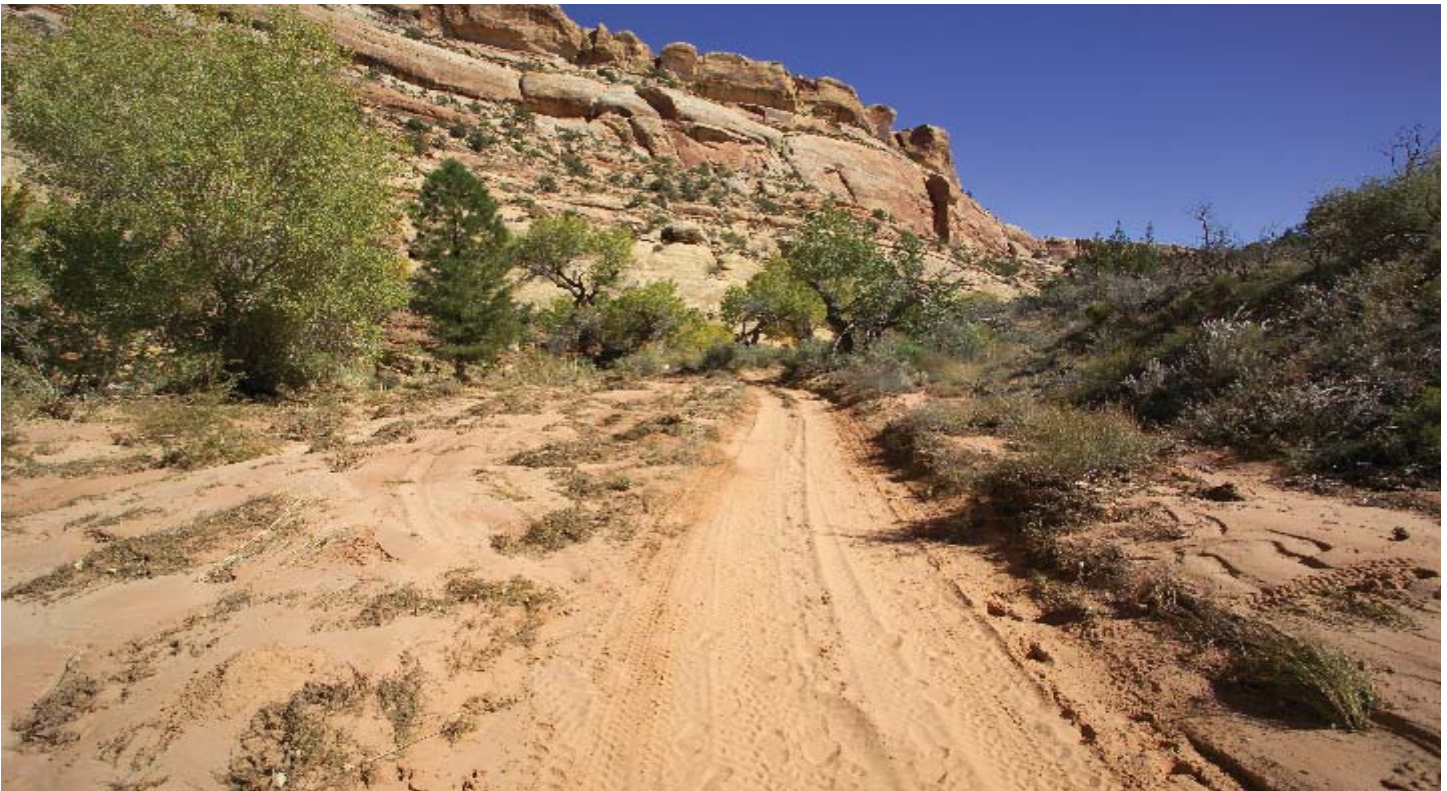
Figure 11a. Photo taken in April, 2006. 4-wheel drive route facing downstream; stream channel is on left. Arch Canyon, San Juan County, Utah.

Figure 11b. Repeat photo of Figure 11a, taken in October, 2006. Flood waters entered the 4-wheel drive route and eroded away the soil, route, and vegetation. This area is now much more susceptible to future flooding events and erosion. With this extensive damage there is also a much higher chance of exotic weeds becoming established. Arch Canyon, San Juan County, Utah.

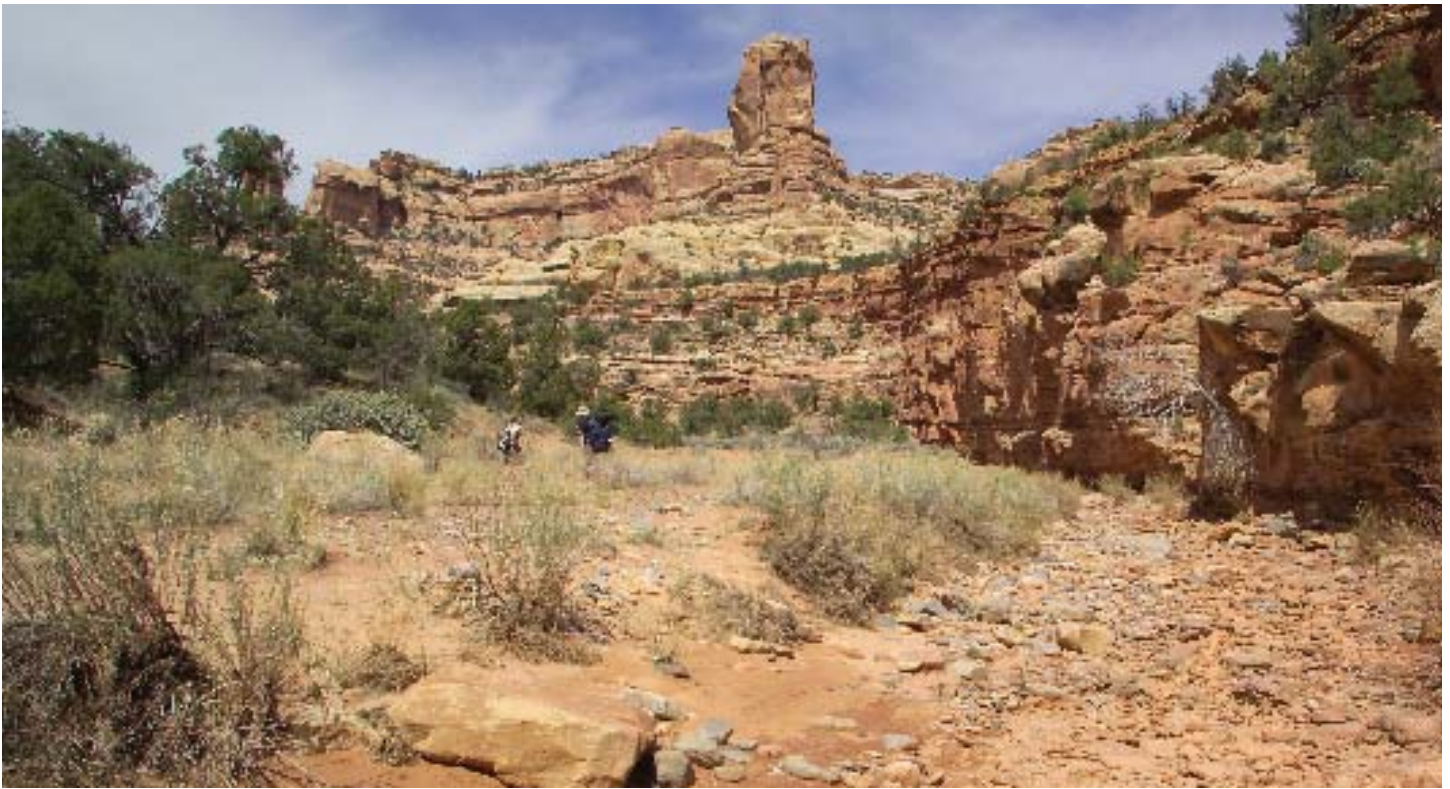
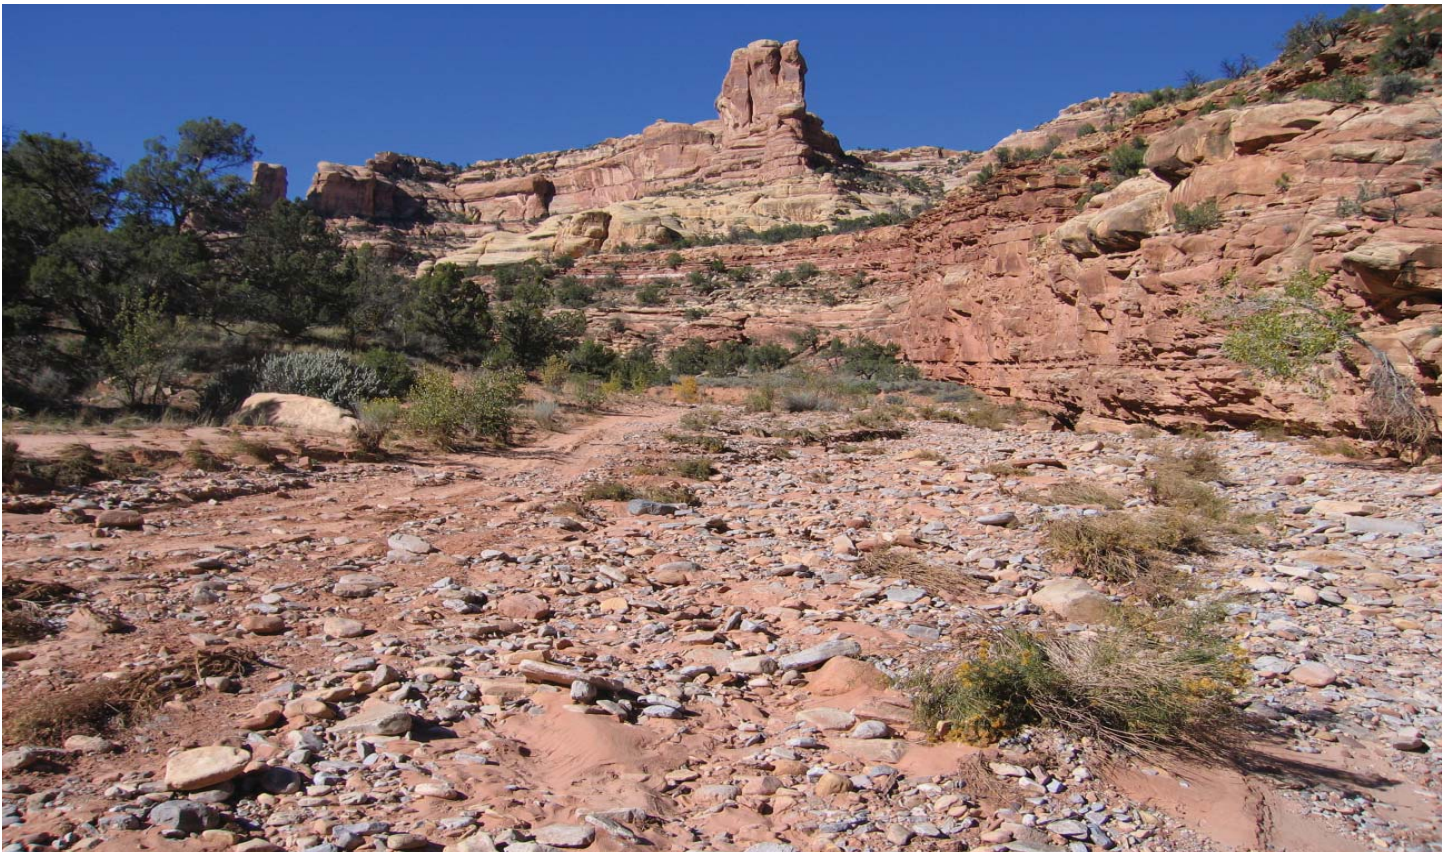
Figure 12a. Photo taken in April, 2006. Upstream view where 4-wheel drive route crosses the stream channel. People are walking on the 4-wheel drive route. Arch Canyon, San Juan County, Utah.

Figure 12b. Repeat photo of Figure 12a, taken in October, 2006. Flood waters jumped onto the 4-wheel drive route and eroded away the streambank and vegetation between the road and the channel. Arch Canyon, San Juan County, Utah.

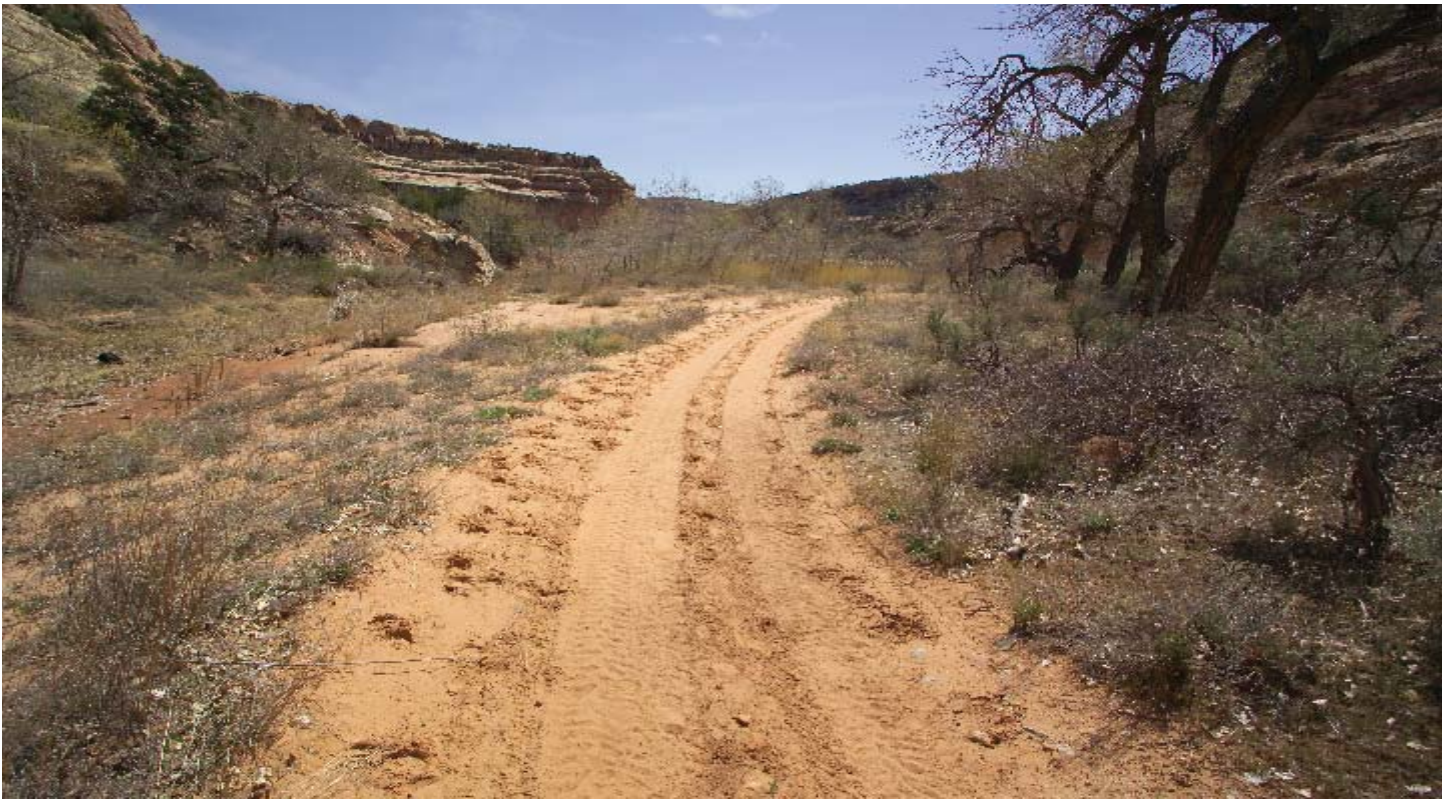
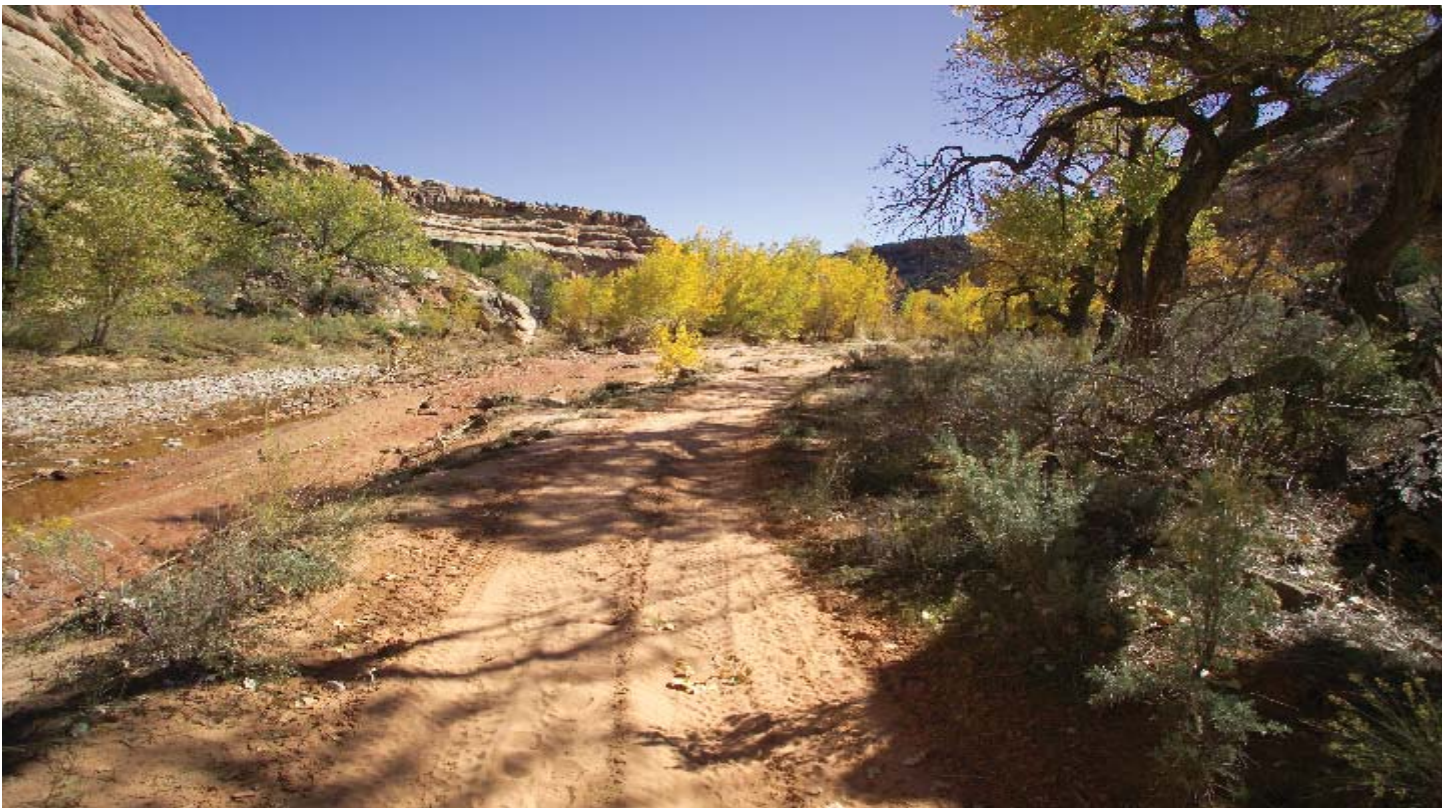
Figure 13a. Photo taken in April, 2006. Stream channel facing upstream; stream channel is on left. Arch Canyon, San Juan County, Utah.

Figure 13b. Repeat photo of Figure 13a, taken in October, 2006. Flood waters jumped onto the 4-wheel drive route just upstream of this location and caused soil and bank erosion and elimination of vegetation. The stream channel has widened and deepened and riparian vegetation has been eliminated from inside the channel. Note the rocks and cobbles that have been exposed in the channel. Arch Canyon, San Juan County, Utah.

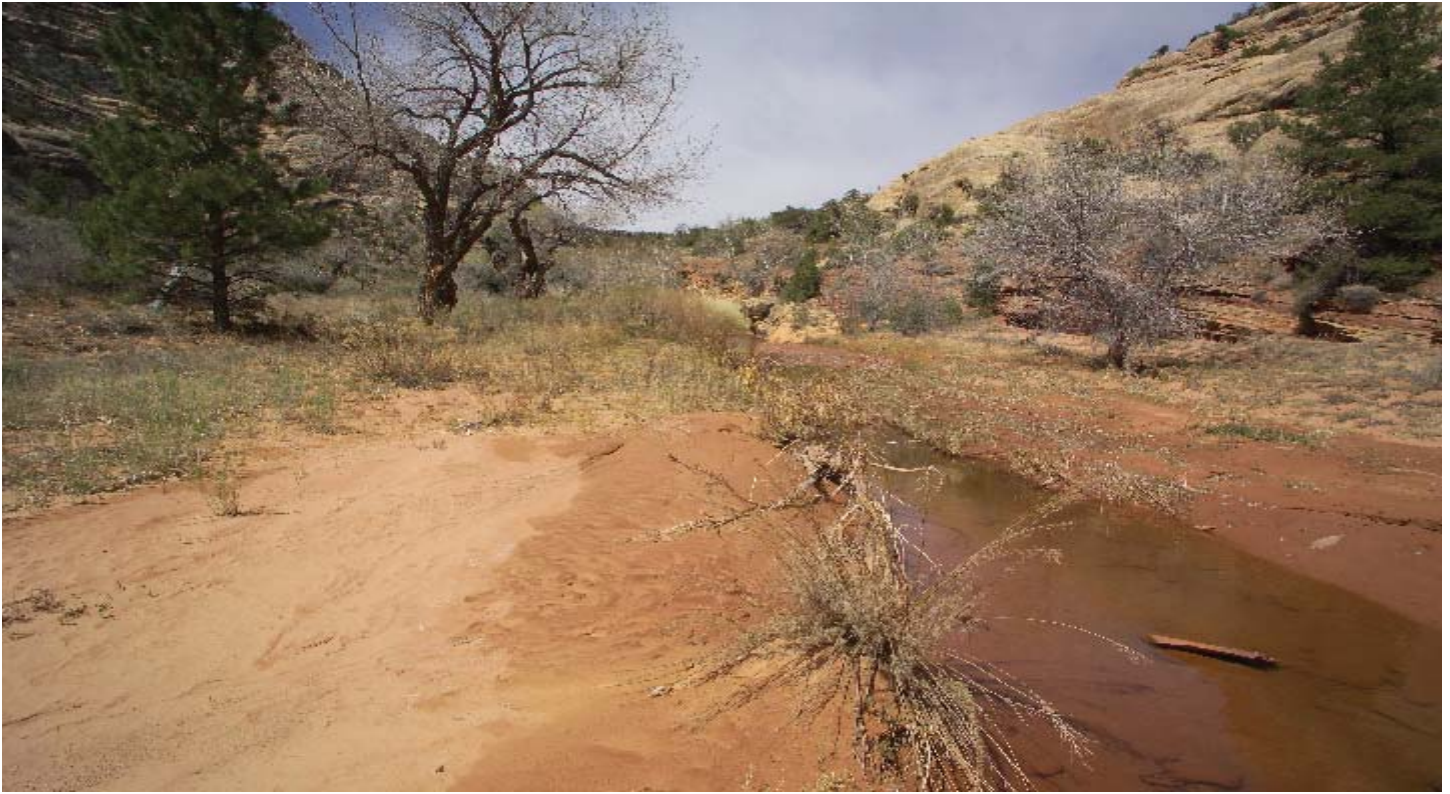
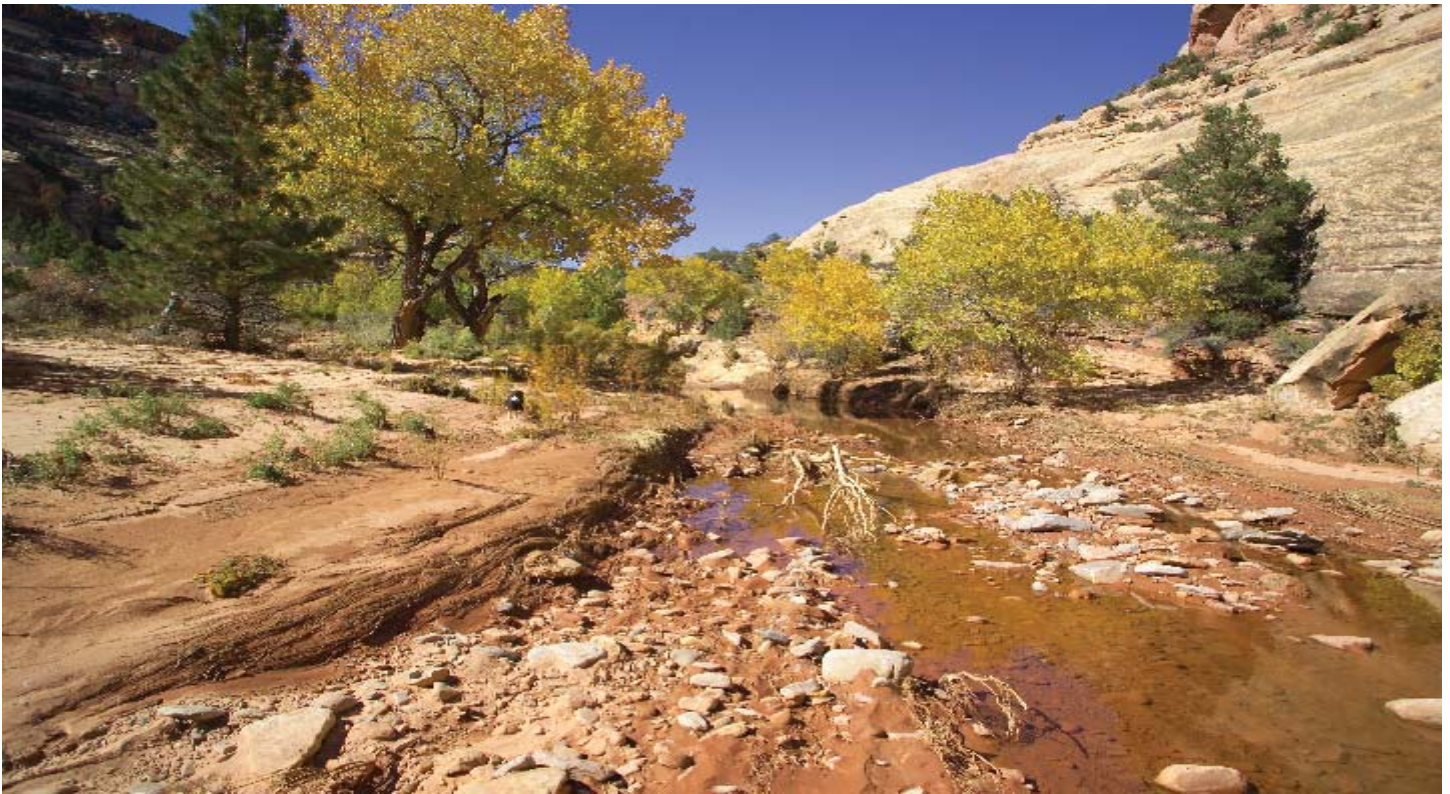
- 4) The loss of fish habitat is visible in the form of soil and streambank erosion, and the loss of overhanging vegetation. This kind of impact from increased energy flow could eliminate the flannelmouth sucker and the bluehead sucker from Arch Canyon. These fish populations are physically separated from other populations and could be rare disjunct populations . Movement patterns, genetic studies, and habitat analyses are needed to answer questions about their viability in Arch Canyon. See Figure or photo set 14.

Figure 14a. Photo taken in April, 2006. Stream channel facing upstream; 4-wheel drive route is out of sight and on left. Arch Canyon, San Juan County, Utah.

Figure 14b. Repeat photo of Figure 11a, taken in October, 2006. The stream channel has widened and deepened and vegetation has been eliminated. Arch Canyon, San Juan County, Utah.
